The façade-tower of Santa Maria delle Stelle church in Comiso. Historical events, vulnerability and conservation strategy

Giovanni Gatto, Gaspare Massimo Ventimiglia Università degli Studi di Palermo - Dipartimento di Architettura

After recalling the historical events of the construction of the façade-tower of Santa Maria delle Stelle Church in Comiso, begun in 1736 and finished two centuries later, the contribution focuses on the theme of the completion of its structure with the use of reinforced concrete, designed by the engineer Santoro Secolo. In more recent times, some sudden collapses have highlighted the theme of risk and the need to reintegrate the structure. Maintenance and conservation strategies are discussed in the final part of the text.

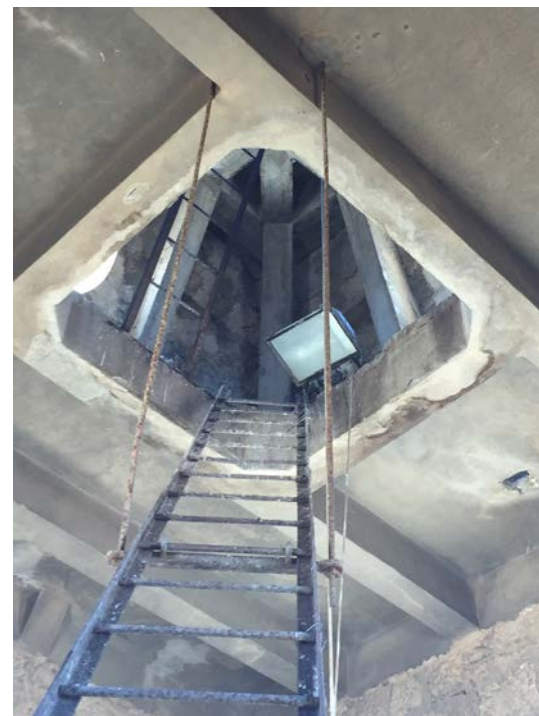
Fig. 4: Interior of the belfry in the upper part of the façade-tower; the structural frame of reinforced concrete is highlighted, 2018 (photo by the authors).

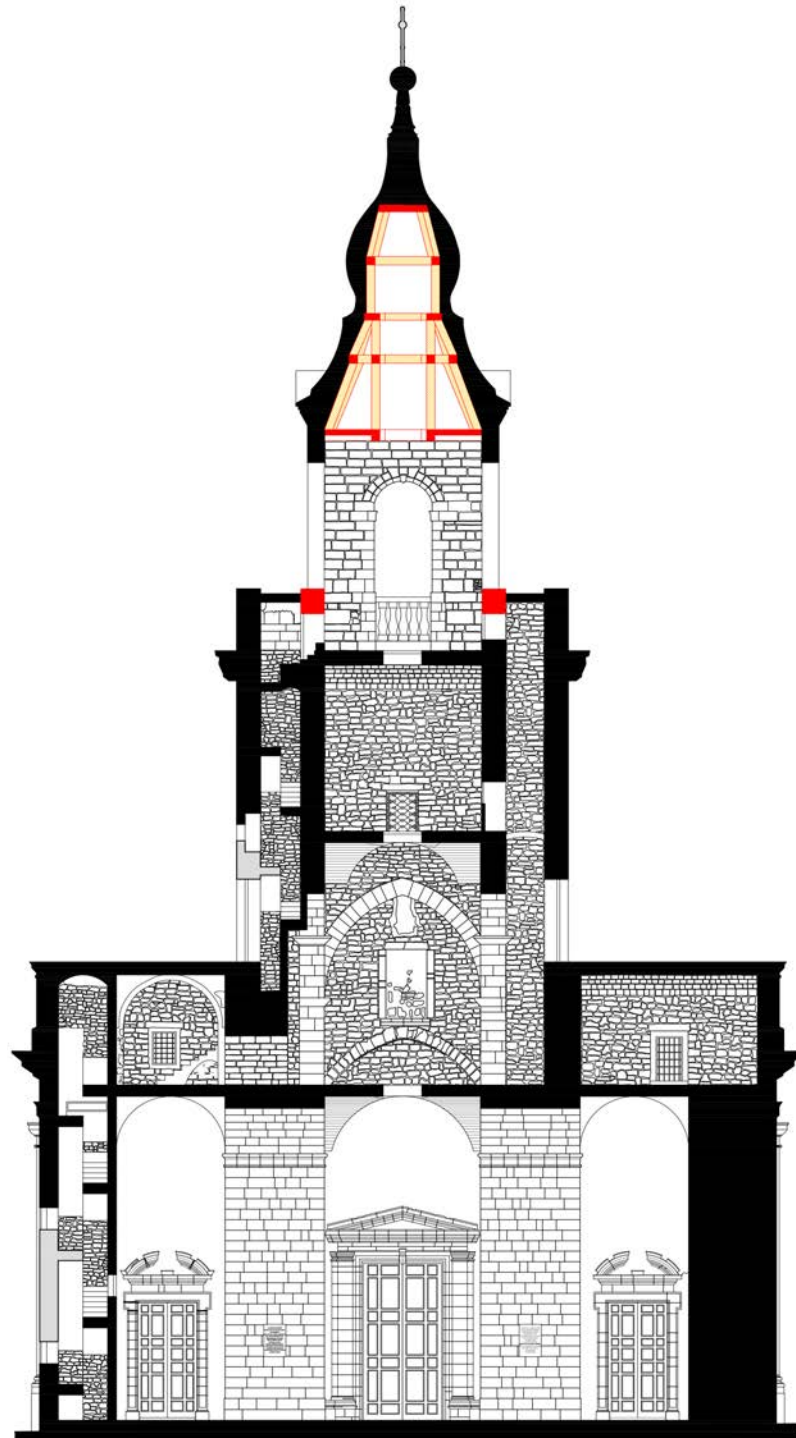
Fig. 7: Comiso, Santa Maria delle Stelle church, architectural survey of the façade-tower, section of its structure. The reinforced concrete elements are highlighted in red [Gatto 2018].

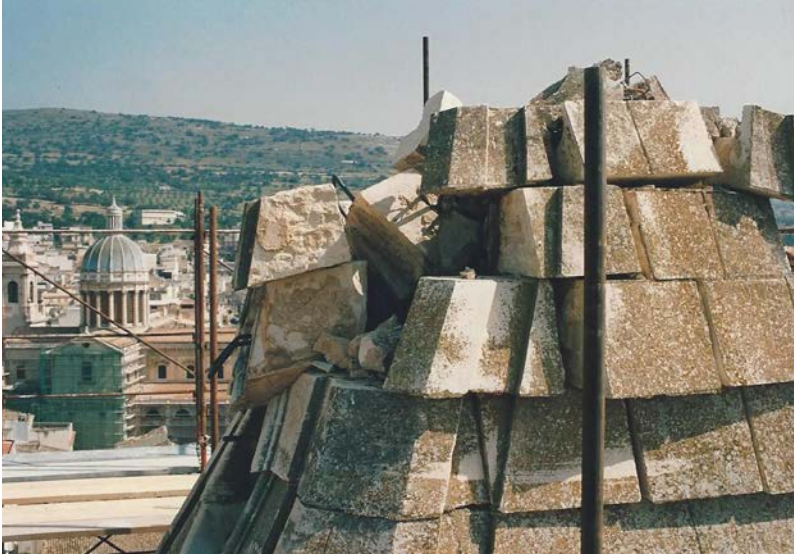
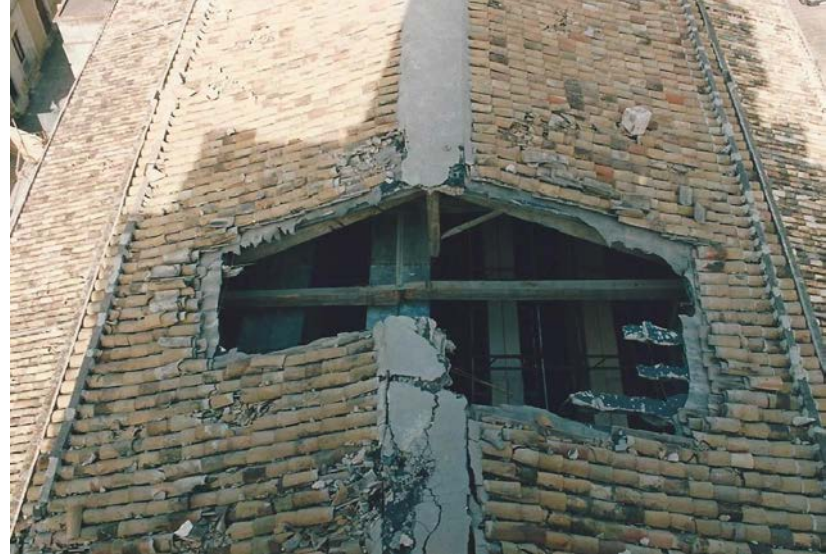
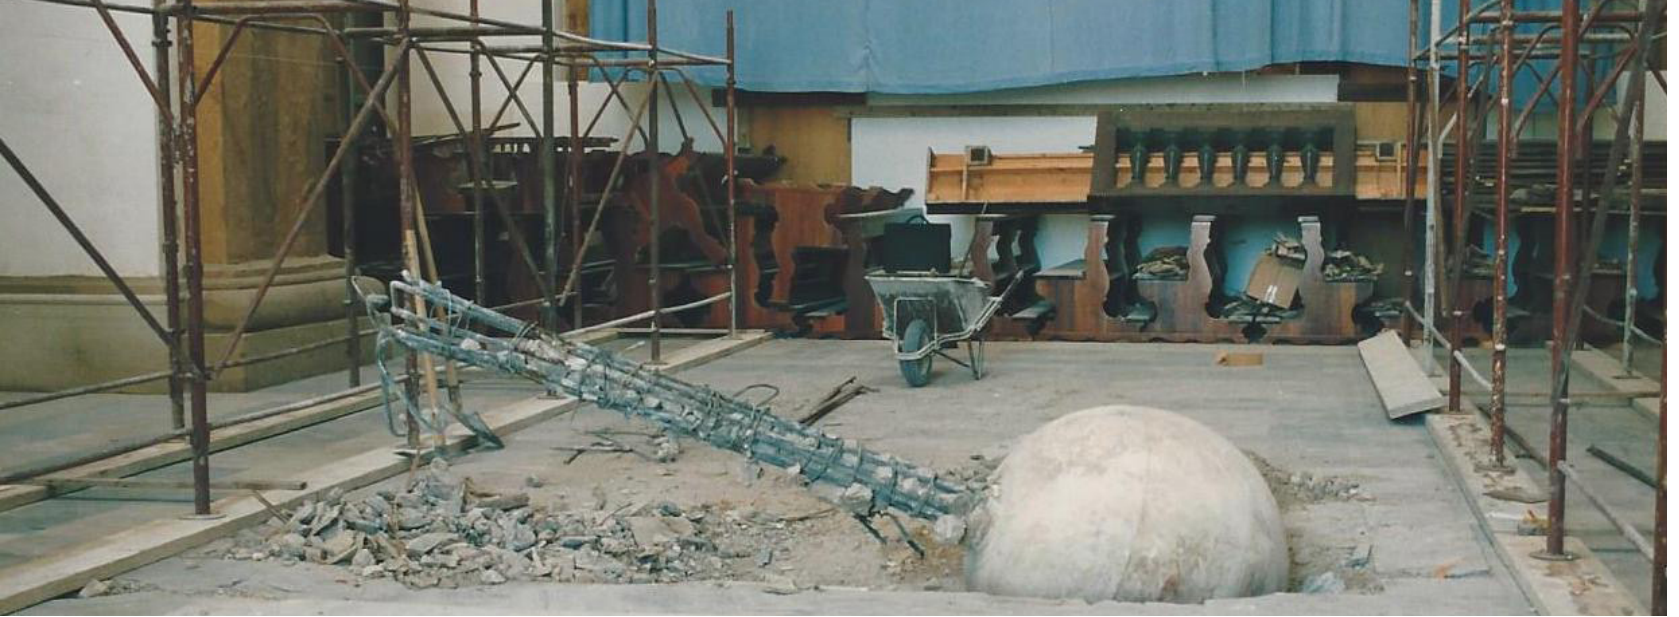
On February 13, 1994, at about nine o'clock in the morning, while a religious function was underway, a few moments after having heard the forceful noise of a thunder during an intense storm, the massive sphere placed on top of the façade-tower precipitated ruinously, causing serious damage to the church. In the rapid descent, the heavy globe, its metallic trellis of anchorage to the summit bulb and the three-meter-high iron cross fixed on it caused a large gash in the roofs corresponding to the main nave of the church, in the painted wooden planks which forms the ceiling and in the pictorial canvases applied to it. Reaching the ground inside the church, the heavy sphere caused a significant damage to the pavement [Strada 1994; Rimmaudo 1994].

Fig. 8-10: Disconnection of the masonry following the detachment of the sphere; Hole in the cover caused by detachment and falling of the sphere; Stone globe with cross in the central nave after falling from the bell tower [Berenato 1994].

del Barbalonga e per una grande tela che è rovinata al suolo»¹⁶. About the explanation of the structural collapse it was thought that «il fulmine possa essere stato attirato dalla grande massa ferrosa del traliccio di sostegno delle campane, traliccio reso solidale alla struttura in cemento armato che costituisce l'ossatura portante rivestita di calcare intagliato della cella campanaria. Quest'ultima parte della facciata fu finita infatti di costruire nel dopoguerra, su progetto dell'ingegnere Santoro Secolo e come si evince anche nella relazione redatta nell'agosto del '92 in occasione del crollo della sfera, il cemento armato dell'epoca presenta numerosi punti di discontinuità con molti ferri in vista»¹⁷.

The Church of Santa Maria delle Stelle was declared unusable once again and the regional councilor Giuseppe Drago went to Comiso in order to evaluate the conditions of the historical building. Shortly thereafter, a joint technical table was set up between the Regione Sicilia, the Soprintendenza di Siracusa and the Genio Civile. The positive opinion for the execution of the works did not delay being pronounced and the restoration site could start in 1994. The population immediately felt the need to relocate the sphere and the cross, launching a fundraiser and a “pro restoration committee”. Regarding the restoration, the possibility of making the parts to be replaced with lighter and more durable materials was not taken into consideration; it was also omitted to consider the question of the distinctiveness of the new inserts as a new stone sphere (once again of Comiso stone) and an iron cross were replaced.

After the removal of the rubble and the installation of the scaffolding on the bell tower and inside the church, it was decided to continue with the removal of unstable stone elements, the execution of small repairs, and the relocation of the new sphere with a cross having the same dimensions and materials as the original ones. Furthermore, the interventions carried out included the dismantling of the damaged trusses and the broken latero-cement floor, the reintegration of the nave roofs with new trusses laid on reinforced concrete curbs and wooden planks, with waterproofing material and tiles¹⁹. The funds to finance the works amount to two hundred million lire; fifty million lire were allocated to intervene on the sphere in 1992.

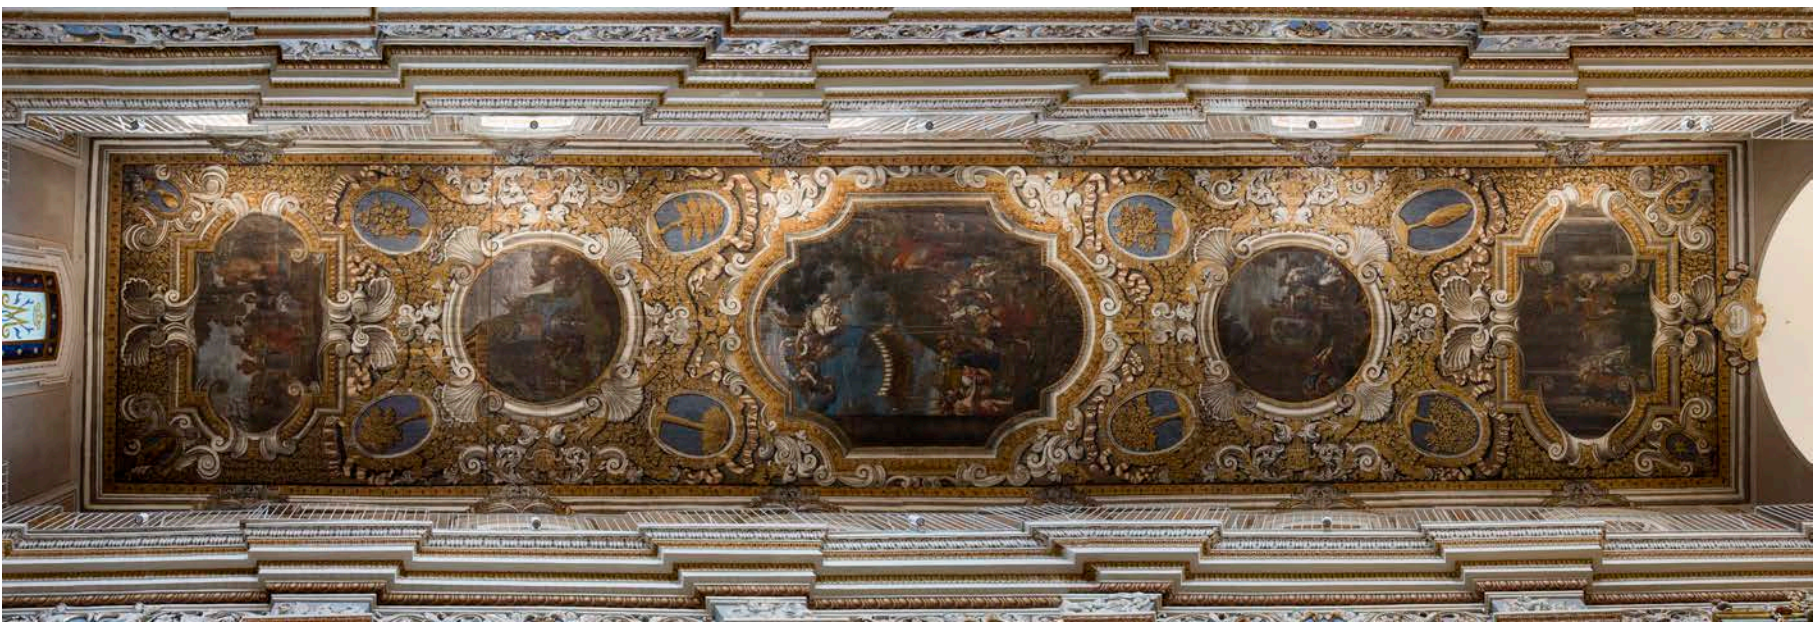
Fig. 11: Comiso, Santa Maria delle Stelle church after the restoration, in 2014. View of the cover of the main nave with the wooden ceiling after the reintegration and relocation of the paintings (photo by Carlo Giunta).

The reintegration and consolidation of the painted wooden planks that make up the ceiling of the central nave of the church took place between 2005 and 2007. The two oil painted canvases torn apart after the breaking of the false ceiling were carefully restored but placed in their original location only during a later restoration site²⁰. The archives of the Soprintendenza di Siracusa and Santa Maria delle Stelle keep the extensive documentation inherent in each phase of the interventions on the building and on the artistic works it contains. A vast and precious photographic documentation is included in the archive of Giuseppe Berenato. Indeed, the church has been affected by an extensive restoration work in 2015, preceded by a scientific investigation campaign prepared by the “Laboratorio di Indagini e Restauro dei Beni Architettonici “Salvatore Boscarino” (Università di Palermo, Dipartimento di Architettura). Non-destructive or minimally invasive diagnostic tests were carried out under the scientific coordination of prof. Francesco Tomaselli (Università degli Studi di Palermo). The performed surveys are radar prospections, thermography, ultrasound auscultations, measurements of humidity by electrodes and video-endoscopic observations. This argument also recalls two episodes in France at the beginning of the nineteenth century that highlight some similarities with the present case study: a lightning struck the spire of the cathedral of Rouen and the same fate later befell Saint-Denis abbey.
