The façade-tower of Santa Maria delle Stelle church in Comiso. Historical events, vulnerability and conservation strategy

Giovanni Gatto, Gaspare Massimo Ventimiglia Università degli Studi di Palermo - Dipartimento di Architettura

After recalling the historical events of the construction of the façade-tower of Santa Maria delle Stelle Church in Comiso, begun in 1736 and finished two centuries later, the contribution focuses on the theme of the completion of its structure with the use of reinforced concrete, designed by the engineer Santoro Secolo. In more recent times, some sudden collapses have highlighted the theme of risk and the need to reintegrate the structure. Maintenance and conservation strategies are discussed in the final part of the text.

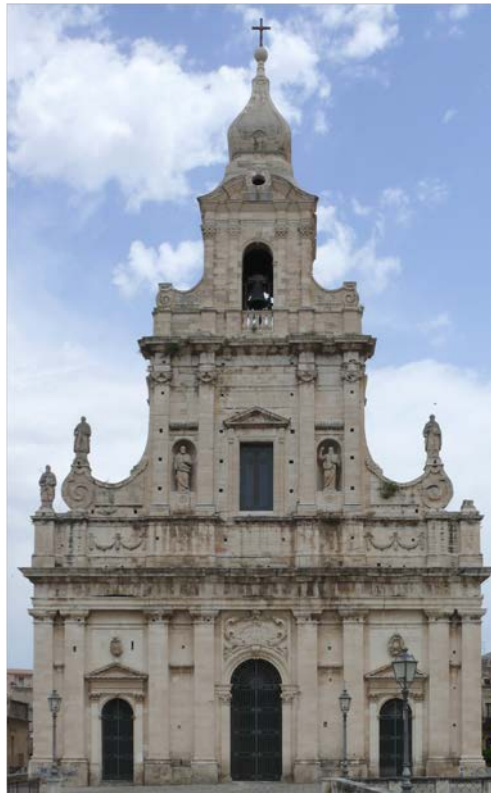
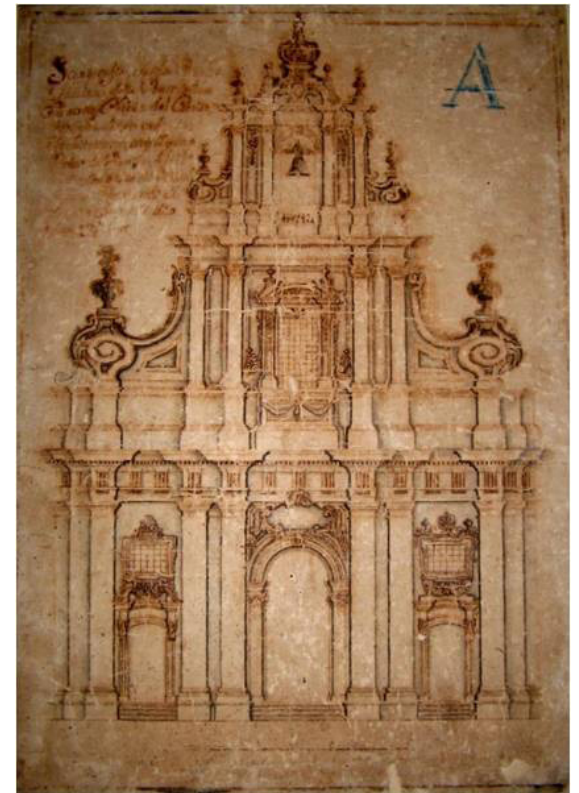
Fig. 1-2: Comiso (Ragusa), Santa Maria delle Stelle church, comparison between the photogrammetric image of the main façade [Gatto 2007] and the design by Rosario Gagliardi elaborated in 1736.

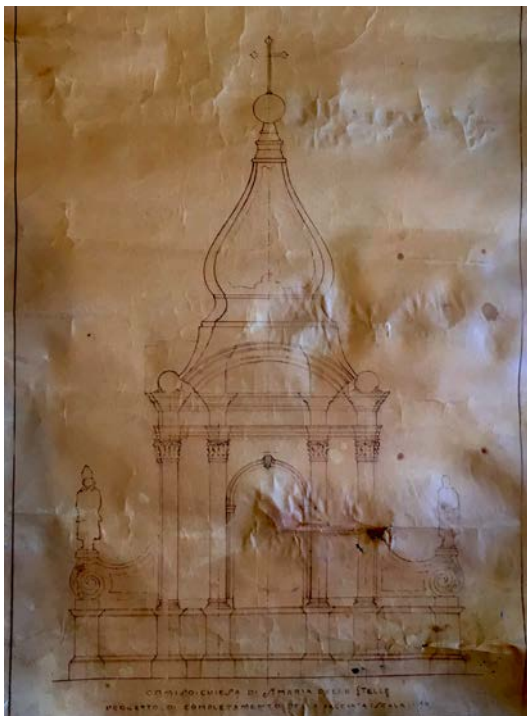
Fig. 5: Santa Maria delle Stelle church with its façade raised up to the level of the second order; the construction site has been interrupted since 1884, Diocesi di Ragusa, APSMS, f. Globo II.

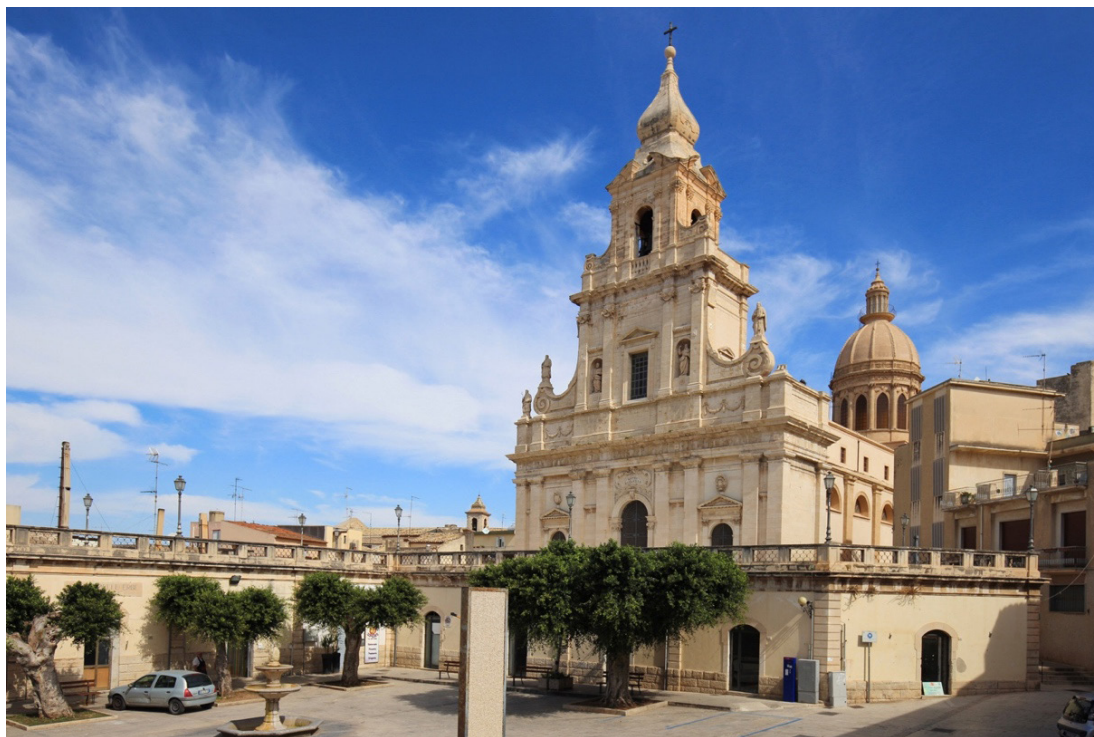
Fig. 12: Comiso, Santa Maria delle Stelle Church after the restoration. View of the church from piazza delle Erbe, 2016 (photo by Carlo Giunta).

The initiatives undertaken to repair the damage caused to the church by the collapses that occurred at the top of the façade-tower have lasted for over twenty years, and have required a great effort by the Diocesi di Ragusa, the Soprintendenza ai Beni Culturali ed Ambientali di Siracusa²², the Genio Civile of Ragusa and the technicians of the Municipality of Comiso. The local press highlighted the development of the complex and articulated affair, keeping alive an intense debate centered on the aspects connected to the responsibility of preserving the cultural heritage and to the issues of risk and environmental protection. As a direct consequence, a widespread social awareness raising action has taken place on the issues of monument maintenance and risk assessment, which also draw the attention of the government of Regione Sicilia. A parliamentary question was presented on 4 August 1992 by Mr Piro, Mele and Battaglia to the Regional Councilor for Cultural and Environmental Heritage and for Education, asking which measures would be undertaken «a tutela della chiesa Madre, del patrimonio artistico della città di Comiso e, più in generale, del cosiddetto ‘Barocco siciliano’»²³. In memory of the event, the recomposed fragments of the sphere ruined to the ground are now exhibited in the area of the narthex and, in 2016, after more than twenty years and three work sites, the restoration of the ancient wooden ceiling has come to an end with the relocation of the paintings. The year ‘1936’, the name of the director of the completion work ‘S. Secolo’ and of the workers ‘Elia e Turtula’ are engraved on the stone sphere that fell from the tower.
